STANDARD DETAILS
PVC PERFORATED PIPE

COTTAGE GROVE, MINNESOTA

PLATE NO.
STO-14

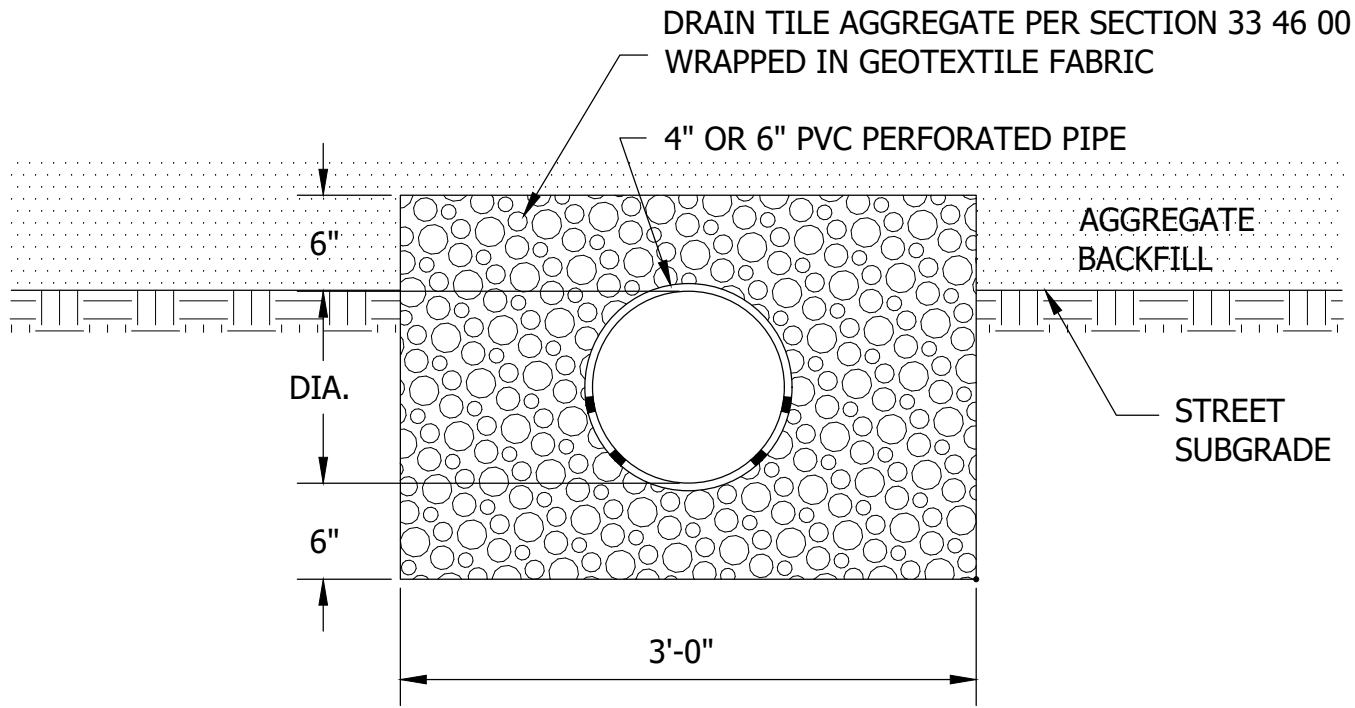
TRENCH DETAIL
